Re: **NONCOMPLIANCE NOTIFICATION**
Administrative Compliance Order and Request for Information CWA-02-2013-3032
And Transmittal of Report from August 28, 2013 EPA Reconnaissance Inspection.
United Talmudical Academy of Kiryas Joel - Bakertown Road, Village of Kiryas Joel, NY
NPDES Tracking Number: NYU400900

United States Environmental Protection Agency
Washington, D.C. 20460
Water Compliance Inspection Report

On August 28, 2013, EPA conducted a Reconnaissance Inspection ("RI") at the UTA of KJ Inc.'s construction site for the Kiryas Joel Boys School on August 28th, 2013. The site is approximately 100 feet north of the Village of Kiryas Joel's Department of Public Works Garage. Murray Lantner of EPA's Division of Enforcement and Compliance Assistance, Water Compliance Branch (DECA-WCB) conducted the inspection along with EPA intern Thomas Parel.

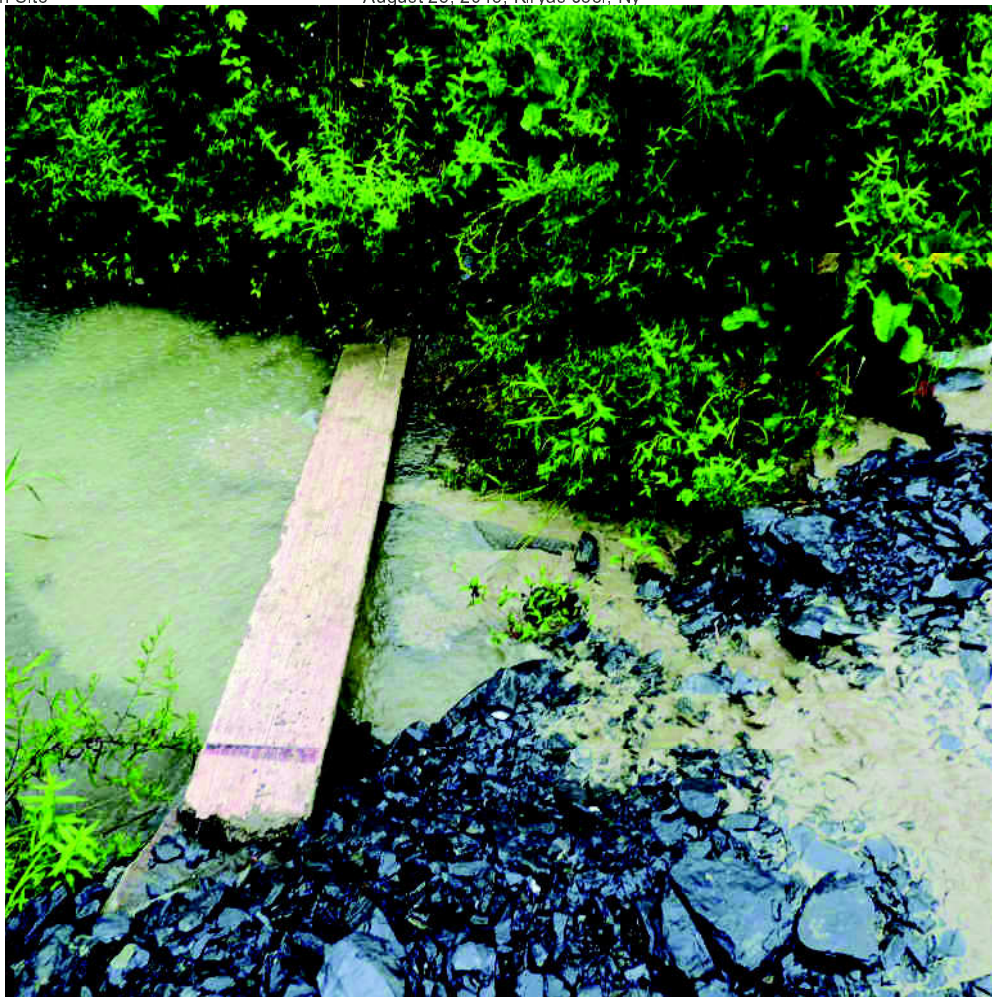
DSCN1450.JPG

1. Entrance road to UTA of KJ Boys School was built across the Highland Brook at the southwest area of the site. Culverts are used to convey the stream from one side of the road to the other. During this inspection, a heavy rain event occurred in Kiryas Joel. EPA observed, turbid run off from the site into Highland Brook at this location. See Photos and Videos 1450 to 1450 in Attachments 1 and 2.

Attachment 1 - Photographs of United Talmudical Academy of Kiryas Joel on August 28, 2013. Taken by Murray Lantner, P.E., Environmental Engineer, Nikon Coolpix P510, EPA Region 2, DECA-WCB	
Photo ID No.	Photo Description
DSCN1450	Turbid discharge from the site flowing into Highland Brook at the south west - downstream - side of the entrance road to the site.
DSCN1451	Turbid plume moving downstream in Highland Brook from the site. Turbid plume begins around the entrance road.
DSCN1452	Flow paths at the site showing the turbid flow into Highland Brook from the UTA of KJ site.
DSCN1453	Video of turbid discharge from the site into Highland Brook and turbid plume moving downstream in Highland Brook.
DSCN1454	Turbid water flowing from UTA of KJ site towards and into Highland Brook.
DSCN1455	Turbid storm water flowing along under the silt fence at the UTA of KJ

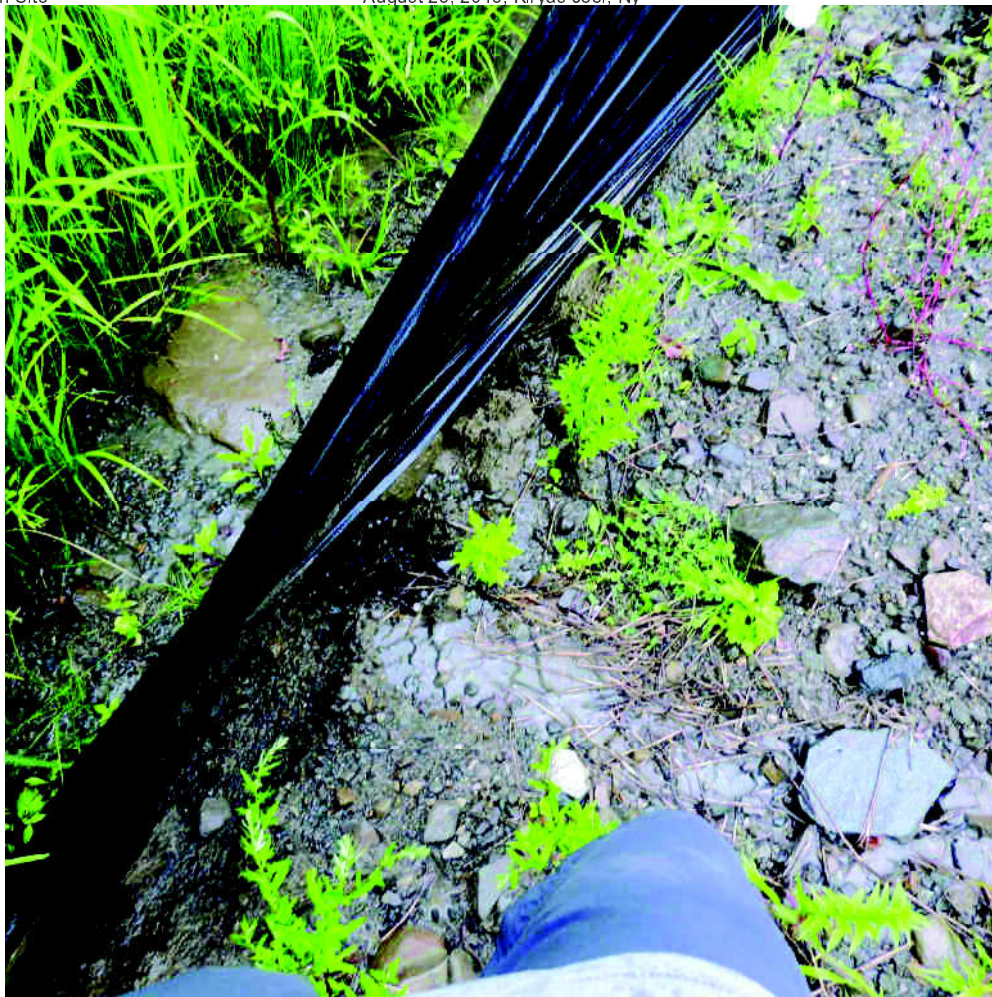
DSCN1455.JPG

2. At multiple portions around the perimeter of the site, the silt fence was improperly installed. The silt fence was not buried into the ground as required and material from the site was able to freely flow beneath the silt fencing. (See Photos/Videos 1455 to 1459) Turbid flows from these point sources were able to enter Highland Brook and its tributary. The silt fences need to be properly installed and maintained in order to prevent discharge of sediment from the site.

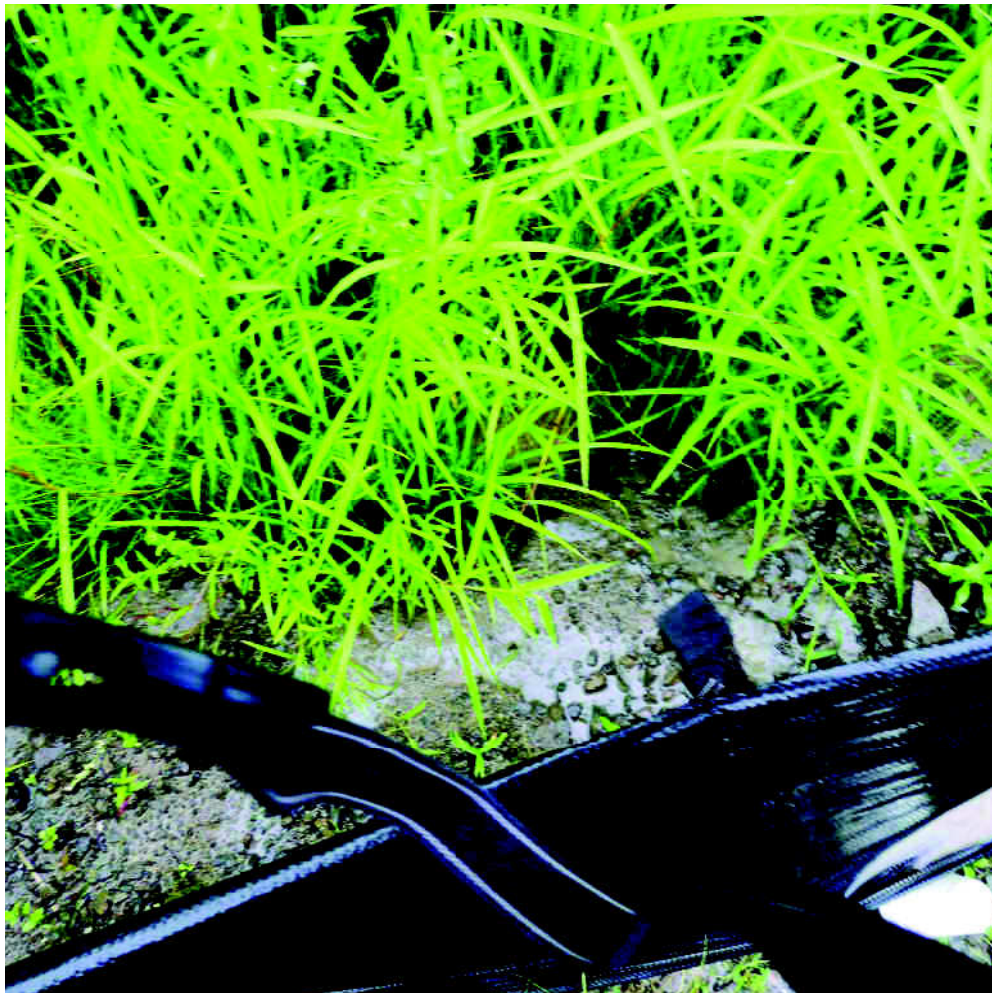
DSCN1458.JPG
Nikon Coolpix P510 Camer

site.
DSCN1456	Video of mildly turbid water coming into a tributary of Highland Brook.
DSCN1457	Video of mildly turbid water flowing under silt fence and into a tributary of Highland Brook.
DSCN1458	Photo of mildly turbid storm water flowing along underneath the silt fence and into a tributary of Highland Brook. Silt fence seen not properly buried into the ground.
DSCN1459	Turbid storm water flowing along under the improperly installed silt fencing. Silt fence seen not properly buried into the ground.
DSCN1460	Video of Turbid water discharge from the UTA of KJ site turning Highland Brook a turbid color. This video demonstrates that the stream changes to a turbid color within a few feet upstream of the entrance road where the heavily turbid discharge from the site begins. It also shows the turbid flow entering the Highland Brook and turning it a turbid brown color.
DSCN1461	Turbidity seen beginning in Highland Brook located at the right side (when entering the site, which is the upstream or east side) of the entrance road to the site. A few feet upstream of the entrance road the stream is seen flowing with less or little turbidity. There are turbid flows from the site also entering Highland Brook from the UTA of KJ on the upstream side and downstream side of the entrance road.

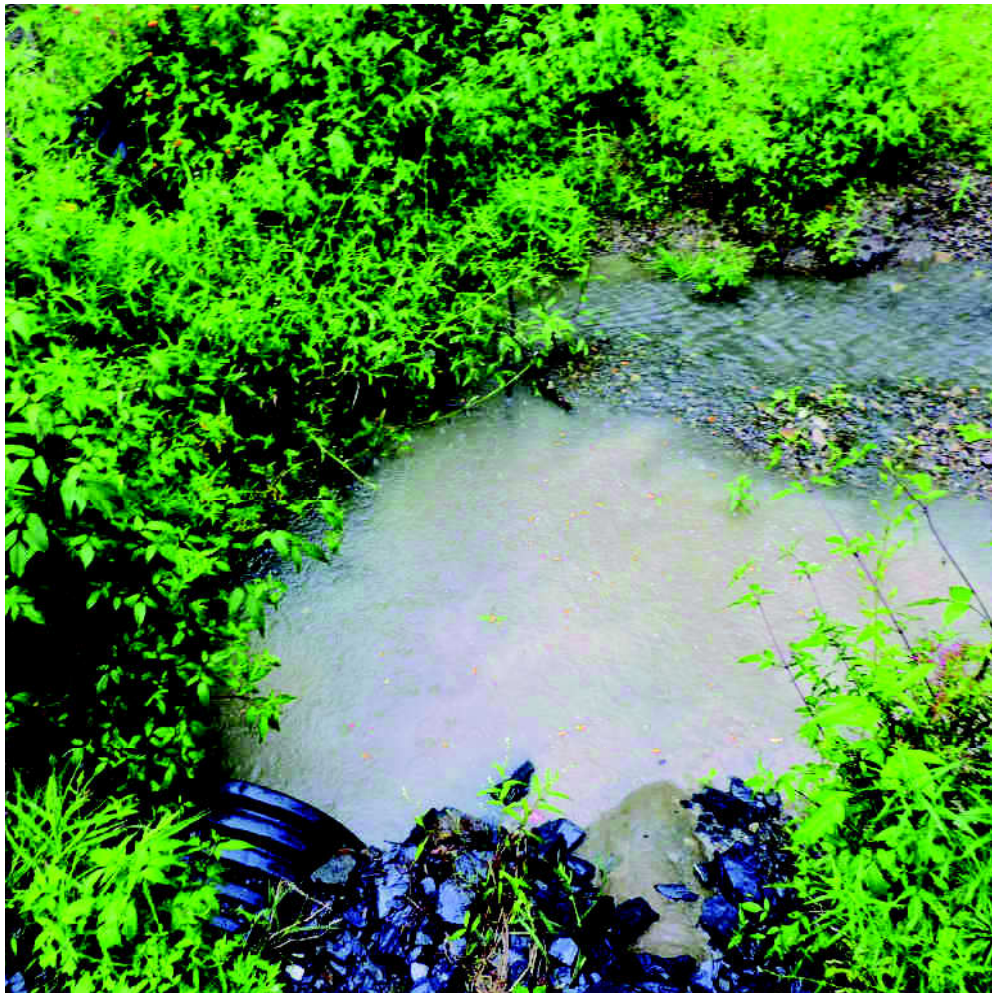
DSCN1461.JPG
Nikon Coolpix P510 Camer

the site caused a plume of sediment within Highland Brook. This plume can be seen flowing steadily downstream from the site in Highland Brook. The plume was documented initially beginning at the site entrance road as shown in Video 1460 (Attachment 2) and Photo 1461 and then continuing downstream (See Photos and Video 1450 to 1454, Video 1460, Photo/Video 1464 to 1470). Adequate stormwater best management practices must be installed on and around the site entrance as well as upgradient of the site entrance to reduce the volume, velocity and pollutant loads in the site runoff.

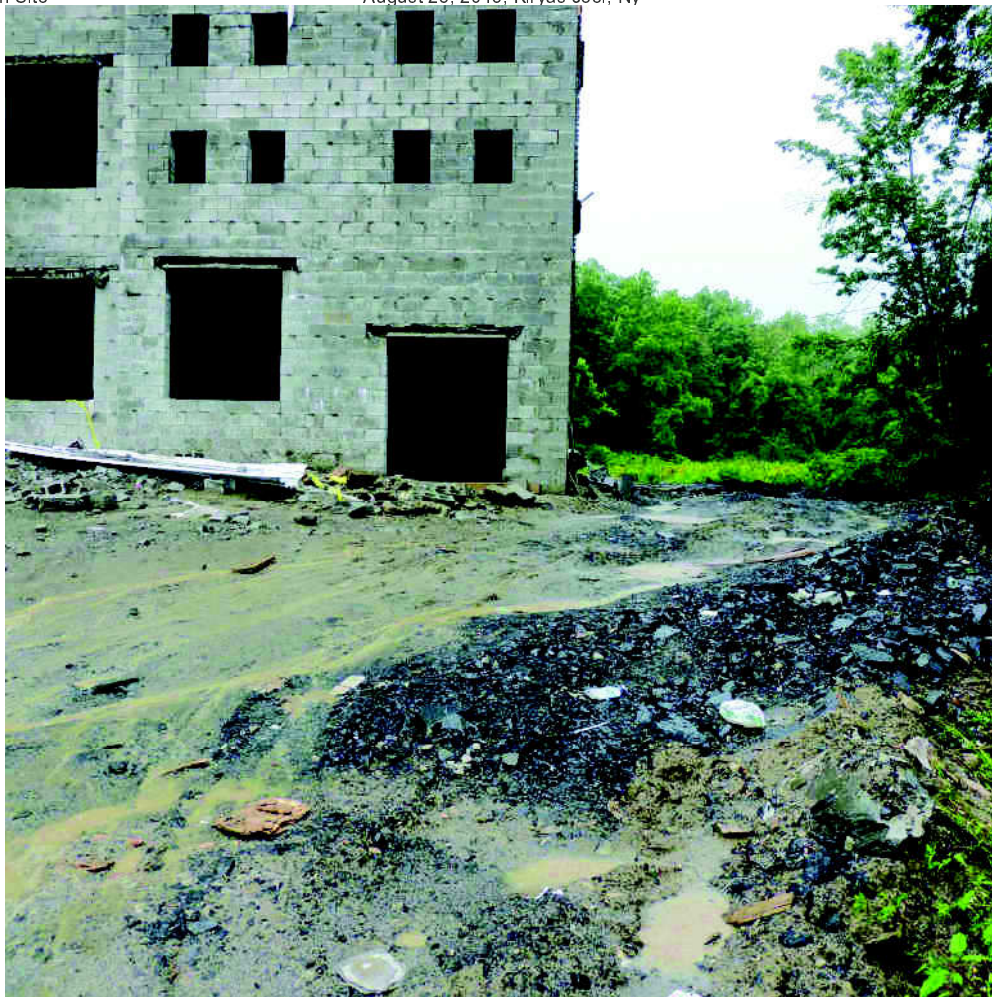
DSCN1462.JPG

DSCN1462	Turbid flow paths seen when looking towards the South side of the site. Just to the east of the site entrance.
DSCN1463	Turbid flow paths seen when looking Northeast from the site entrance.
DSCN1464	Turbid water flowing from the site and entering Highland Brook on the downstream side of the entrance road.
DSCN1465	Turbid water from the site entering Highland Brook on the downstream side of the entrance road.
DSCN1466	Turbid water from the site flowing from the entrance road and entering Highland Brook on the downstream side of the entrance road.
DSCN1467	Turbid plume covering the much of the visible portion of Highland Brook on the downstream side of the entrance road.
DSCN1468	Turbid plume covering the much of the visible portion of Highland Brook on the downstream side of the entrance road.
DSCN1469	Video of turbid stormwater entering Highland Brook on the downstream side of the entrance road and the turbidity seen extending downstream in Highland Brook.
